TRECOM TECHNICAL REPORT 64-9

**COMPILATION AND ANALYSIS OF TEST DATA
ON FIBERGLASS-REINFORCED PLASTICS**

March 1964

**KAMAN AIRCRAFT CORPORATION
Bloomfield, Connecticut**

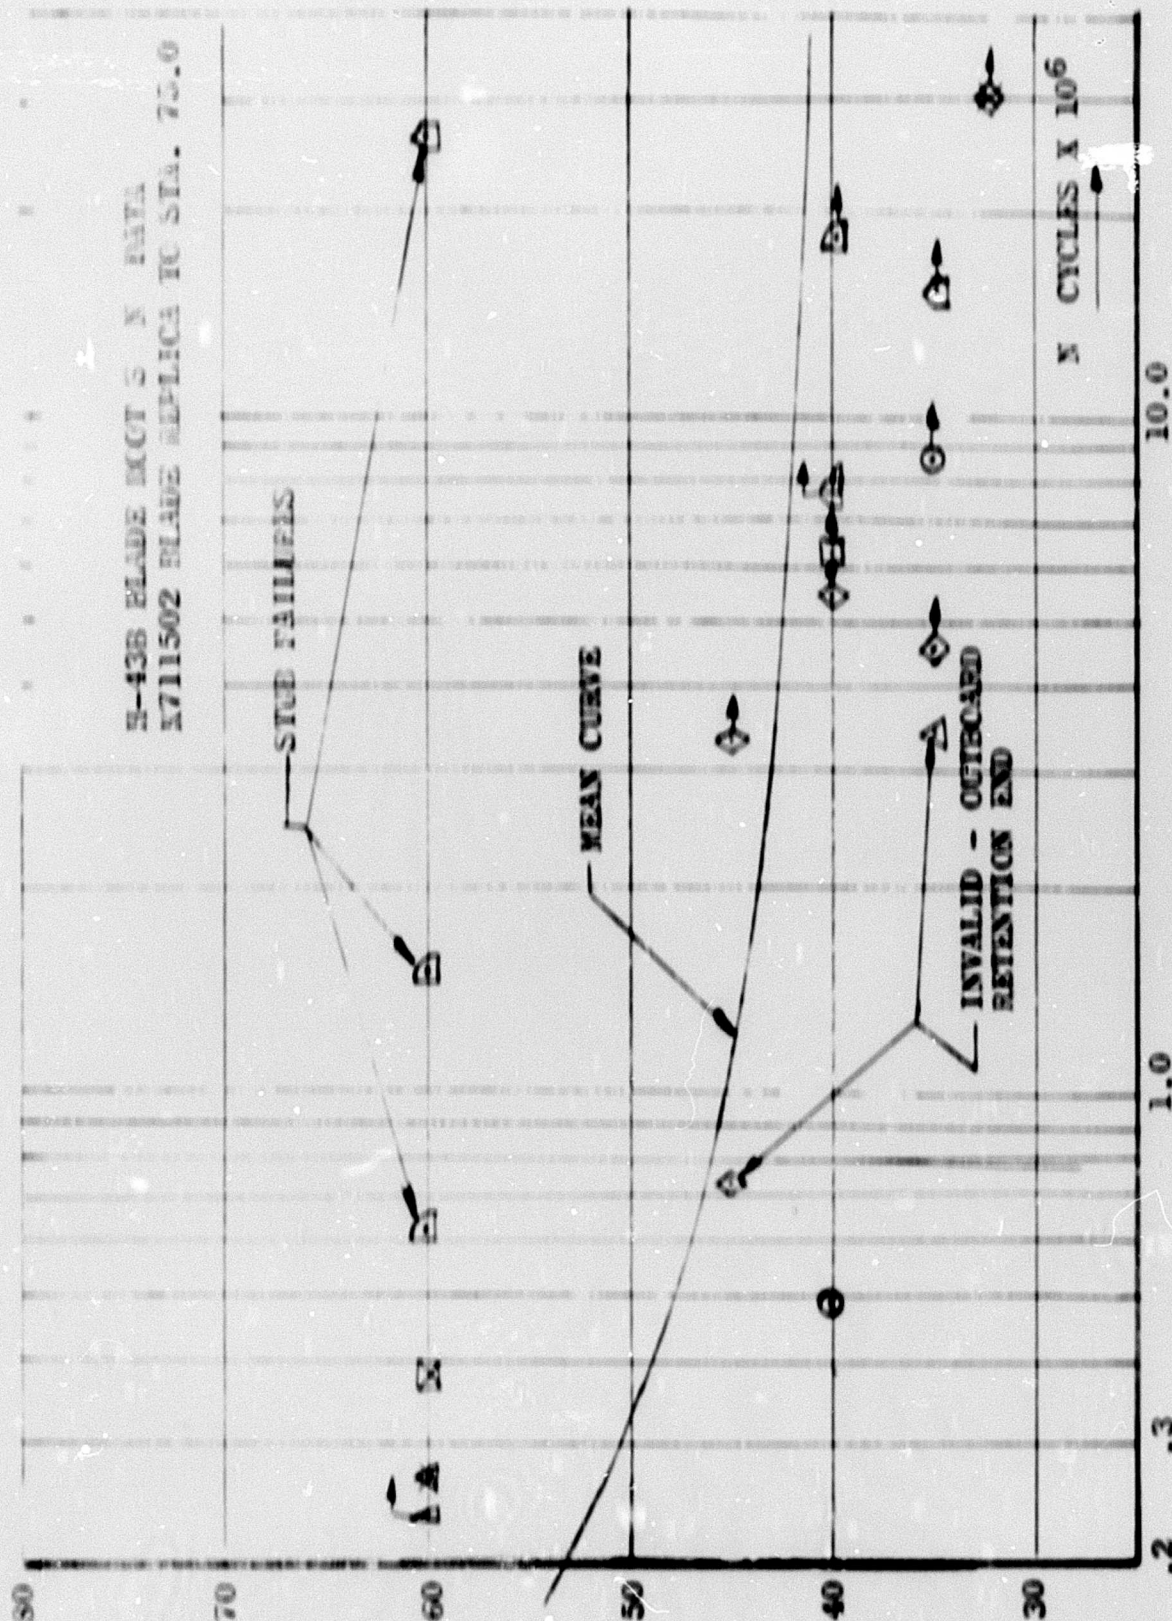
Figure 11-42. Blade Root-End S-N Curve

The prime fatigue location in the rotor blade retention area is the blade grip attachment bolt holes, the most critical being the outboard holes Nos. 6 and 7. Slight spanwise cracks manifest themselves in the Scotchply cheek facings. The unidirectional Scotchply has exceptional spanwise strength properties and fair chordwise strength properties. Previous experience has shown that without the Scotchply cheek plates, chordwise cracks would result with ultimate failures occurring across the net blade section. The spanwise cracks in the Scotchply have an extremely slow rate of propagation and are not considered critical.
